## **REPORT OF MARINE SURVEY (Confidential) NUMBER 020522**

In accordance with your request for a marine survey of "MAUI MAGIC," official number 1149645, for purposes of evaluating its present condition and estimating its fair market value and replacement cost for insurance purposes, I herewith submit my report.

The subject vessel was personally inspected by the undersigned on February 5, 2022, while hauled out on blocks at The Phoenician dry dock, Kapolei, Hawaii.

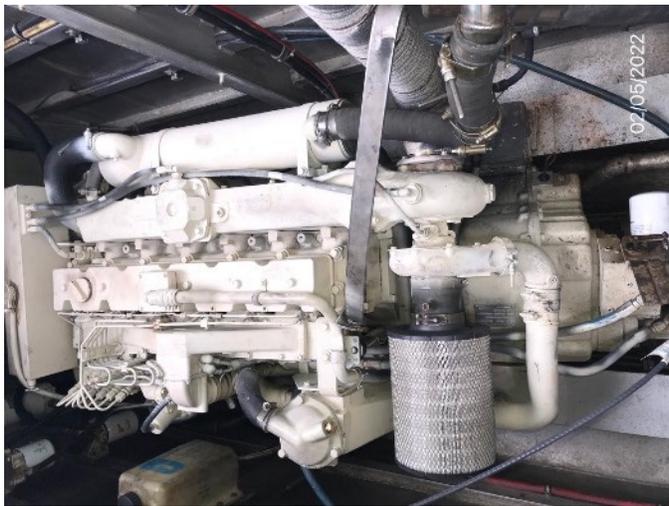
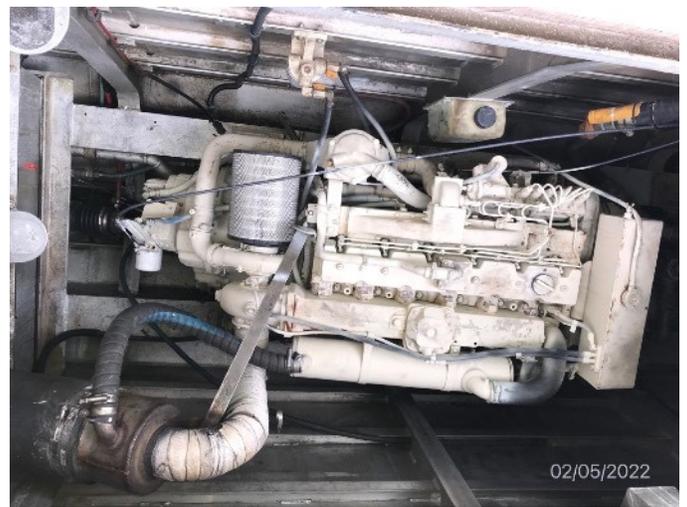
**General condition/summary:** All of the machinery systems were professionally maintained and in good condition.

**Recommendations:** None.
