# All Island Marine Survey LLC

## **REPORT OF MARINE SURVEY (Confidential) NUMBER 110224C**

In accordance with your request for a marine survey of the Catalina 400 MK II, "**HULLABLOO**," U.S. Coast Guard Documentation Number 1192836, for purposes of evaluating its present condition and estimating its fair market value and replacement cost, I herewith submit my report.

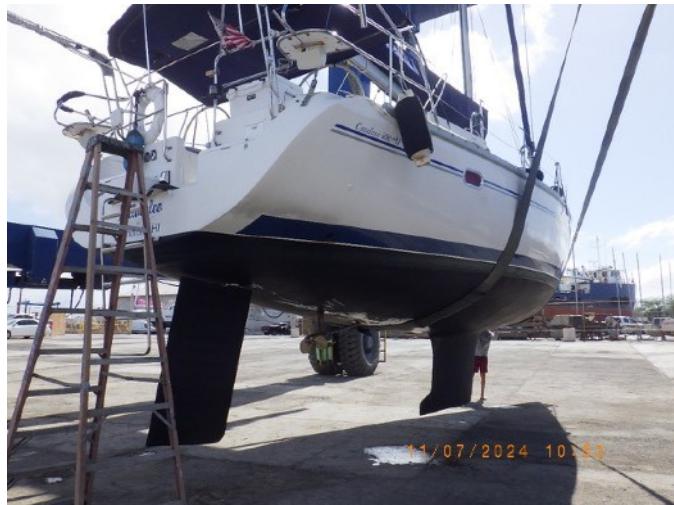
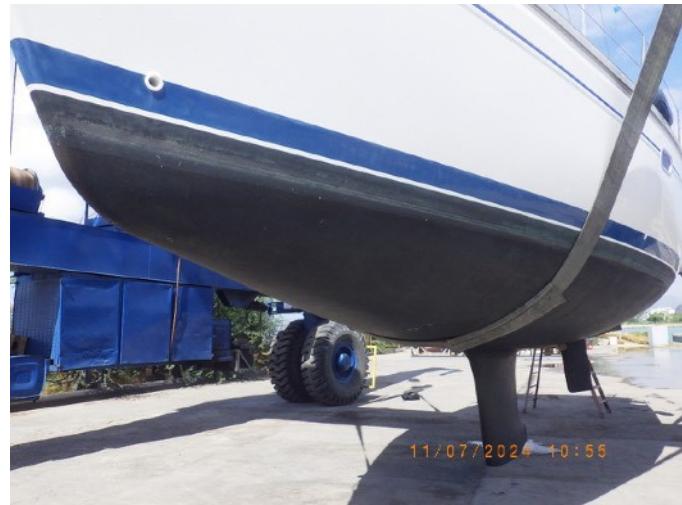
evidence of delamination. The hull above the waterline is white gelcoat, was polished and in good condition, without damage or notable blemishes. The decks are factory nonskid and were in good condition, without soft spots or areas of delamination noted. The hull and internal structures, where sighted, were in good condition, and I found no evidence of previous repairs or disrupted structural members. Engine stringers and fuel tank support structures were intact. The mast is deck stepped and is supported by an aluminum compressor post that is stepped on the keel area. The mast step on deck and the compressor post base support in the bilge were intact, without evidence of fracturing or movement. The stainless steel keel bolts were without significant corrosion.

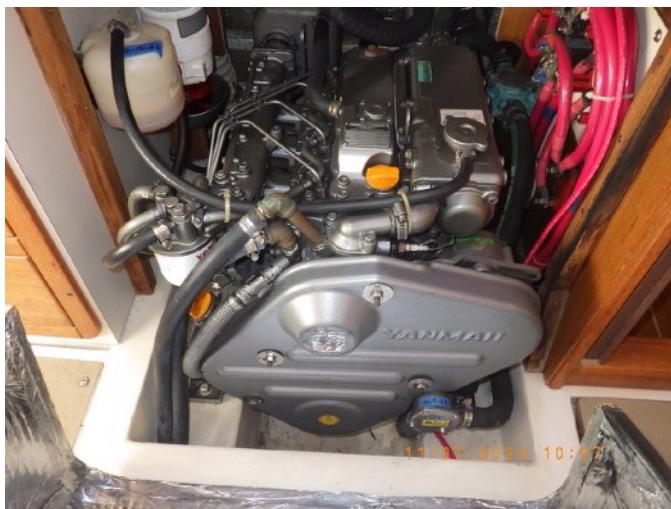
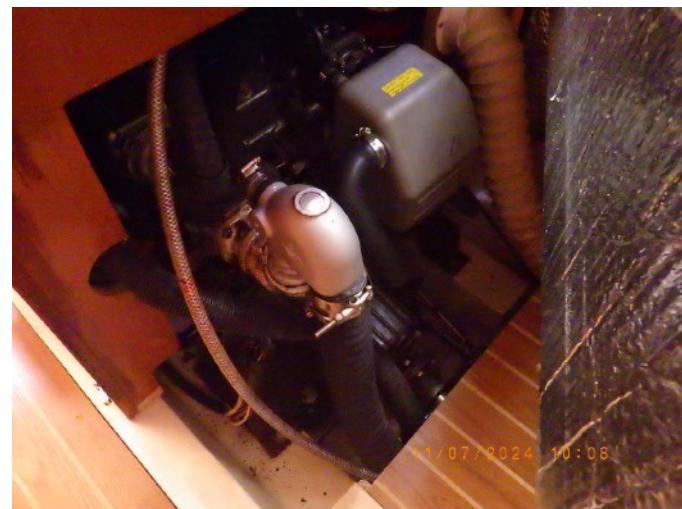
**Engine type:** (1) Yanmar 4JH4E; engine #E014449; HP: 50; engine hours: old hour meter sighted on board reads 1,686.5; currently installed gauge reads 75.0; total hours: 1,761.5.

**Summary:** The engine operated normally during the sea trial and there were no fuel oil, engine lubricating oil, exhaust, or cooling water leaks noted. There was no excessive vibration or smoking. The aft end of the engine showed some surface rust, possibly from the raw water siphon loop vent leaking on the exhaust cooling water circuit, but there was no noticeable leakage during the sea trial.
