REPORT OF MARINE SURVEY (Confidential) SURVEY NUMBER 062420

NOW LOTUS

In accordance with your request for a marine survey of the Beneteau 37, "EXCELSIOR," Official USCG Documentation Number 1260465, for purposes of evaluating its present condition and estimating its fair market value and replacement cost, I herewith submit my report.

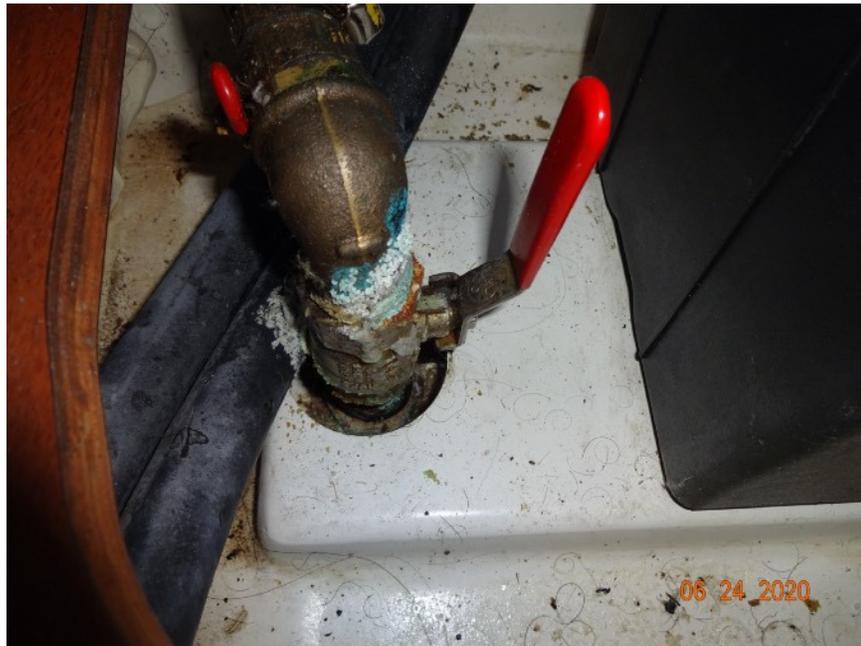
Engine cooling: Seawater cooled via freshwater heat exchanger; bronze ball valve; Vetus 330 basket strainer; clean and lubricate the bronze ball valve assembly, which is exhibiting some active corrosion.

- Through-Hull Fittings,** **Below the waterline:** Bronze thru-hull fittings and bronze ball valves, in good condition, with exception of the engine cooling raw water valve which is in need

of cleaning / lubrication and further inspection.

Recommendations: Provide new hose clamps for the Volvo dripless propeller shaft seal vent line fitting. Provide cleaning and lubrication and further inspection for engine raw water bronze ball valve assembly, which is exhibiting some active corrosion.

Recommendations: Provide cleaning / lubrication / further inspection for the engine raw water valve (see photo below).
