SAILING VESSEL SEA QUILL  
CONDITION & VALUATION SURVEY

19 May 2023, SV SEA QUILL, Moored at Ala Wai Boat Harbor 800 Dock  
1651 Ala Moana Blvd, Honolulu, Hawaii 96815.

**Date of Issue**  
31 May 2023

### CONDITION & VALUATION SURVEY

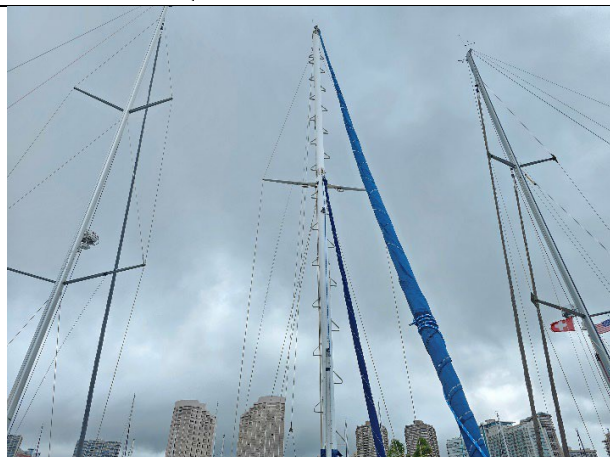
Mast

| <b>MAST</b> | Elliptical-shaped, extruded anodized aluminum mast stepped to the cabin top and supported by a compression post. There were no signs of movement, stress fractures, or excessive corrosion, all in good order. |

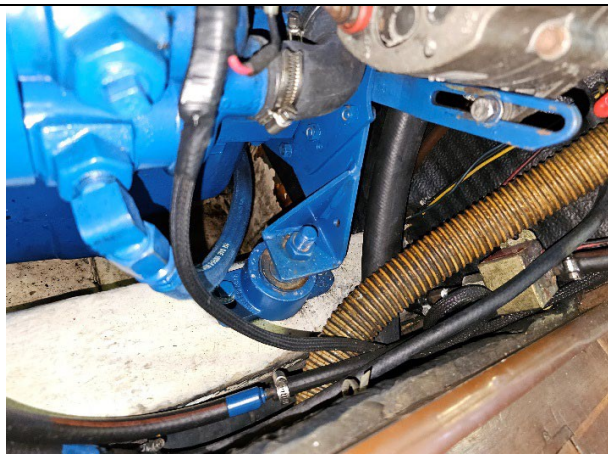
Motor Mount

| <b>ENGINE MOUNTS</b> | Vibration dampener mounts on stringers. No visual signs of movement and stress fractures. |

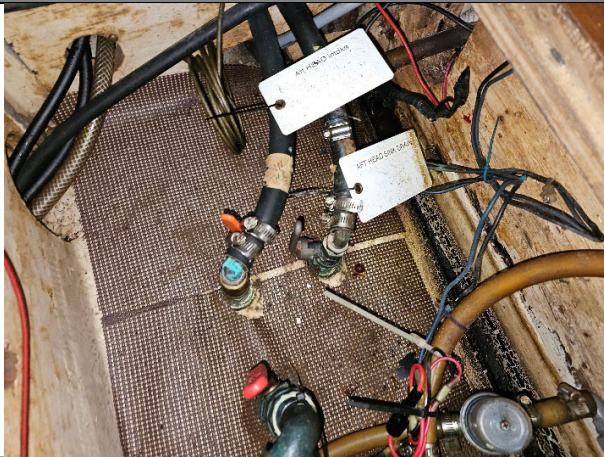
Galley Thru-Hull Valves

| <b>THRU-HULL VALVES</b> | Bronze ball valves. All operational. |

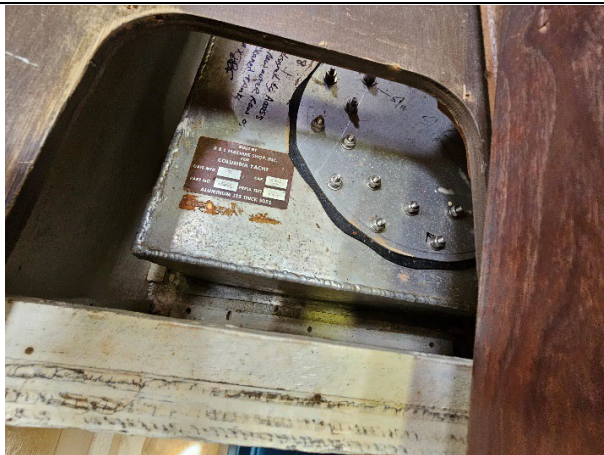
Port Fuel Tank

| <b>FUEL SYSTEM</b> | Fair; Aluminum tanks in good condition, lines intact. |
