SAILING VESSEL SEA QUILL  
CONDITION & VALUATION SURVEY

19 May 2023, SV SEA QUILL, Moored at Ala Wai Boat Harbor 800 Dock  
1651 Ala Moana Blvd, Honolulu, Hawaii 96815.

**Date of Issue**  
31 May 2023

### CONDITION & VALUATION SURVEY

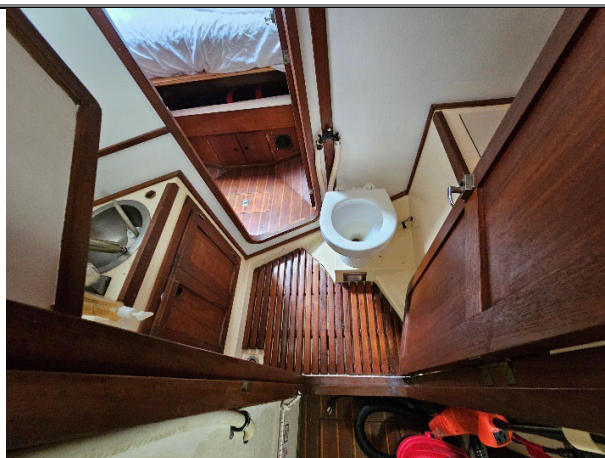
Aft Head

| <b>HEADS</b> | Appears sound; Overboard discharge valves closed. No leaks. |

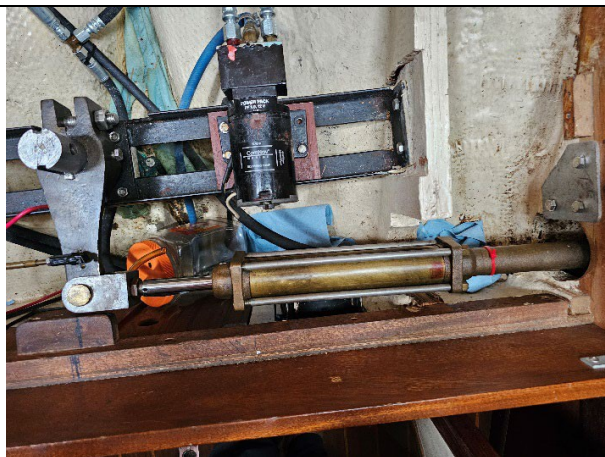
Steering

The steering hydraulic system was seen to be operational. The hydraulic cylinders were recently replaced. The autopilot was reportedly to be in good working order.

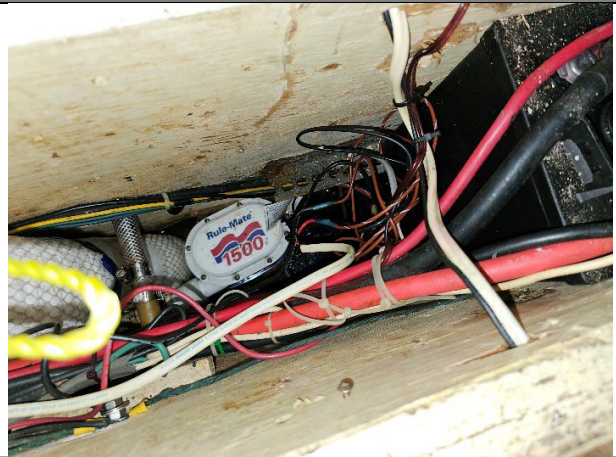
Keel Sump

| <b>KEEL</b> | The lead ballasted fin keel is with casted stainless bolts is fasted to the hull with stainless nuts accessible in the bilge. |
