# All Island Marine Survey LLC

## **REPORT OF MARINE SURVEY (Confidential) NUMBER 040723C**

In accordance with your request for a marine survey of the 2003 Cabo 43' flybridge sport fisher, "**SUMMERTIME**," Official USCG Documentation Number 1133308, for purposes of evaluating its present condition and estimating its fair market value and replacement cost, I herewith submit my report.

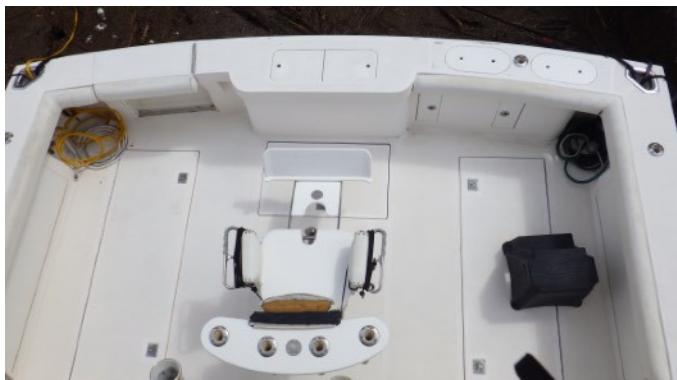
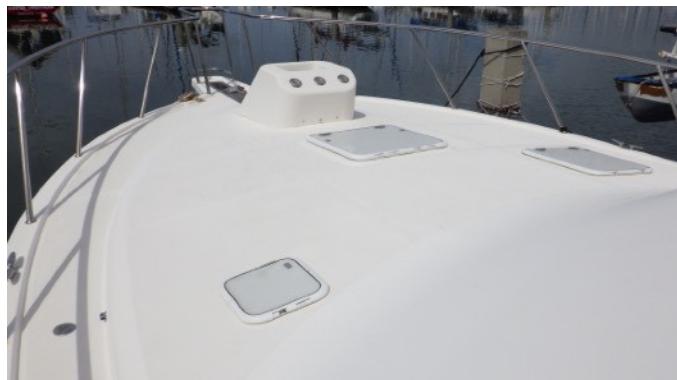
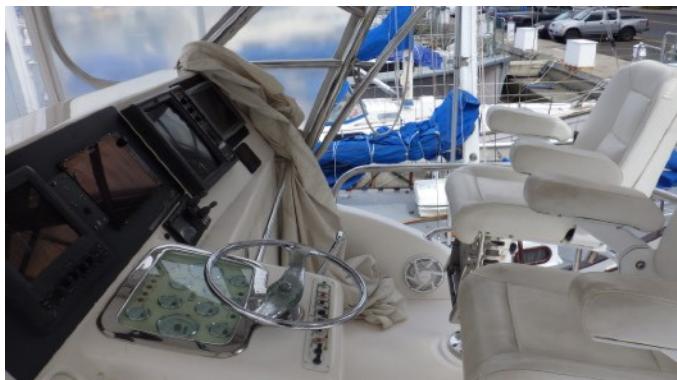
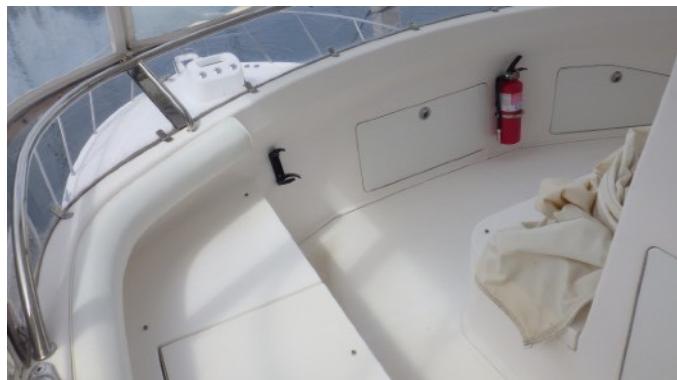
The foredeck is arranged with a molded bow pulpits with anchor chain roller, mooring cleats, electric anchor windlass, raised bait station for fishing from the bow, and three aluminum-framed acrylic deck hatches that open to the cabin spaces below. Polished stainless steel railings surround the foredeck and lead aft, ending along the cabin trunk. From the foredeck, narrow walkways lead aft along the cabin trunk to the cockpit, which is rigged for sport fishing with gunwale-mounted rod holders, below-deck fish holds, built-in transom bait well, in-transom tuna tubes, swing-open transom door, and Pompanette fighting chair. A built-in cabinet forward to port is fitted with a top-loading bait freezer, rigging sink, and access hatch to the engine room. The forward starboard corner of the cockpit is fitted with a built-in ice cooler and throttle controls. The ladder leading to the flybridge is located forward to port. The flybridge is arranged with steering console offset to starboard and has full engine controls and instrumentation. Aft of the console are twin swiveling pedestal chairs. The helm console has a full array of navigation and communication equipment. Opposite the helm station to port is a built-in longitudinal settee that opens for storage, and there is a second bench seat built into the forward side of the steering console. The flying bridge is covered with an aluminum-framed composite hardtop, and there are twelve welded-on rod holders attached to the aft railing that are accessible to the helmsman.

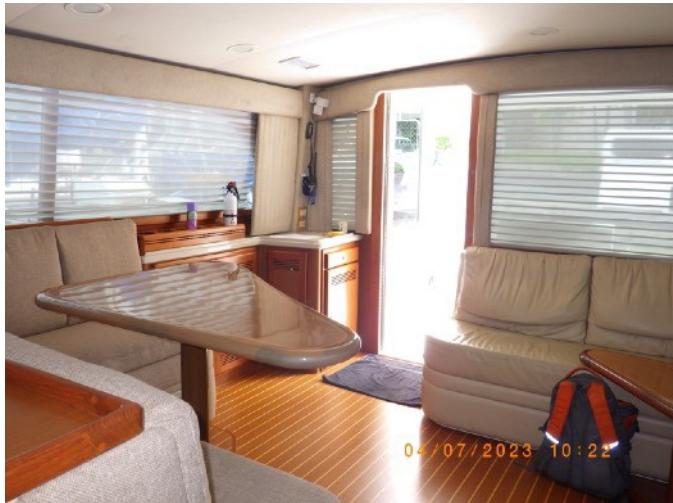
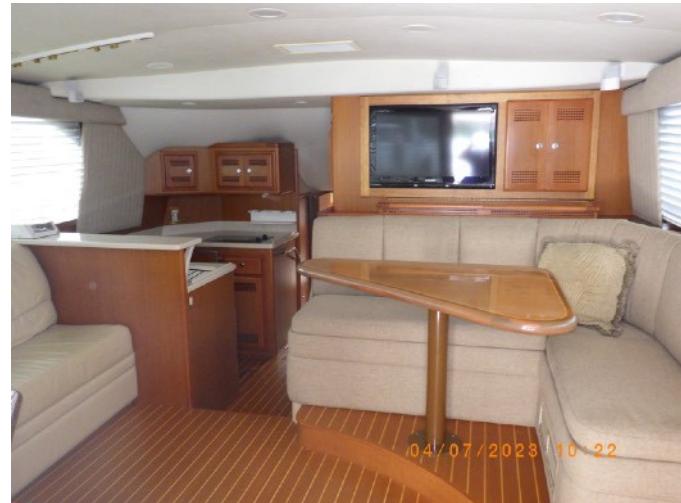
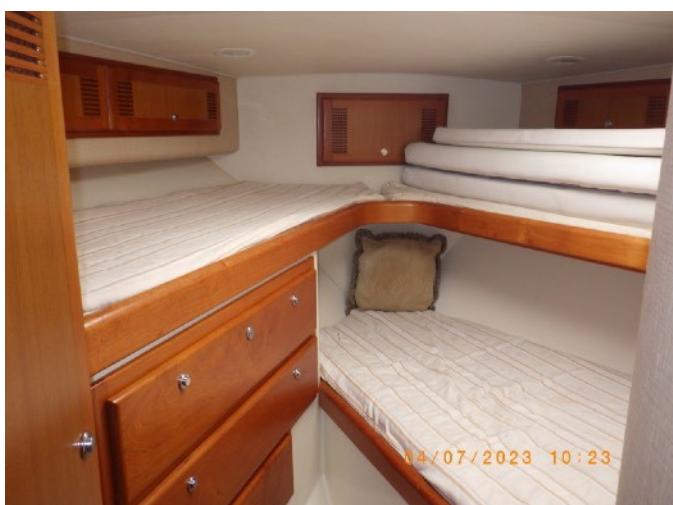
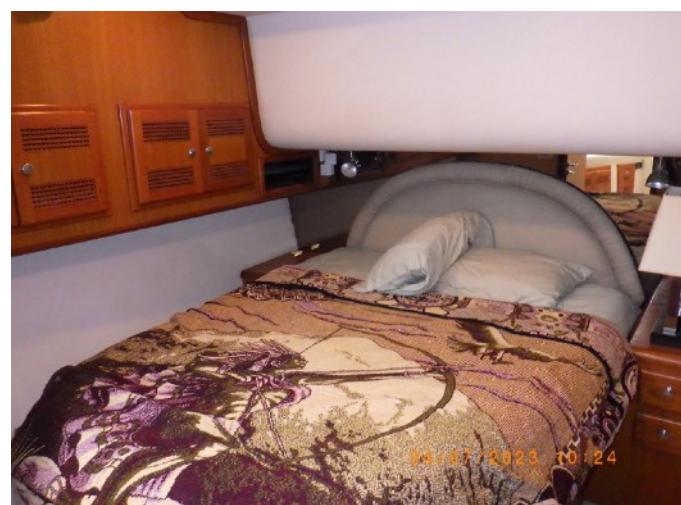
Down below, starting forward, is the crew cabin with stacked single berths starboard and single berth port with cabinets and drawers below. The forward cabin has cabinets above on each side and lockers in the aft corners. The berth has storage below. Walking aft to port is an enclosed head with shower sink vanity and Vacuflush

commode, and opposite to starboard is the master cabinet with queen pedestal berth and en-suite head with separate shower stall, Vacuflush commode, and sink vanity. Walking aft and up a couple of steps, the U-shaped galley is located to port and includes a Sub-Zero freezer and reefer drawers, a two-burner glass electric stovetop, single composite under-mount deep sink, microwave/convection oven, and Corian countertops. Walking aft from the galley and up another step is the salon area, which is arranged with L-shaped settee with triangular dining table to starboard and full length L-shaped lounge to port. A storage cabinet located in the aft starboard corner is fitted with the vessel's main electrical breaker panel and wet bar. Forward of the dining settee is an entertainment center with large TV and Bose surround sound system.
